Pioneer steering control

Interface power feed issue

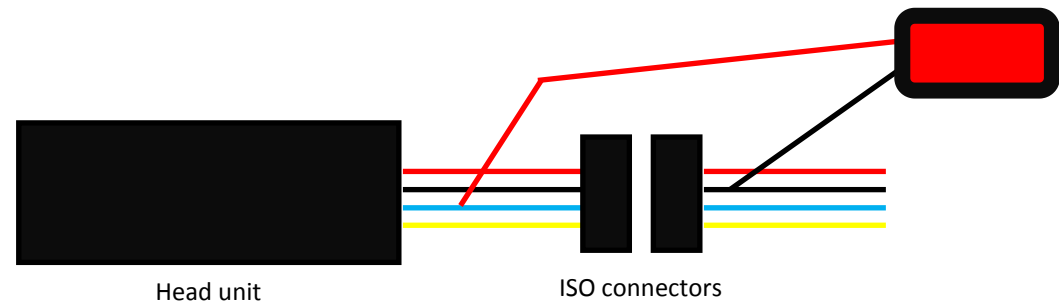
Some new Pioneer head units do not respond correctly to the steering controls. This is due to a voltage supply issues from the car to the interface.

To fix this issue, disconnect the red power wire to the interface from the ignition power in the ISO connector.

Use the blue antenna output trigger from the new headunit to power the interface as shown below.

Using the output trigger (blue wire) from the head unit to power the interface will fix the steering control issues.
