29-713

Component List

Installation Instructions

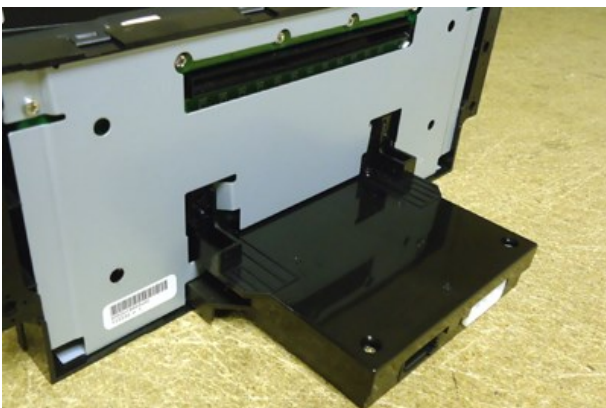
The control module connected to the front button panel needs to remain powered and connected in the car, our FK-853-5 fitting kit has extension leads (CAB-MOST-100) to relocate this module to the passenger footwell. The footwell panel can be easily removed and the button panel reattached to the module to allow the time and date settings to be updated.

6. Undo the screws holding the control module to the front button panel.

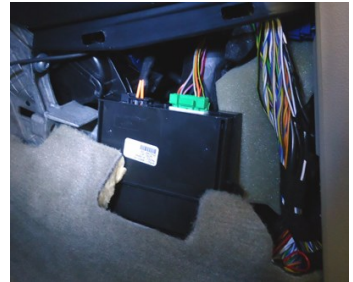
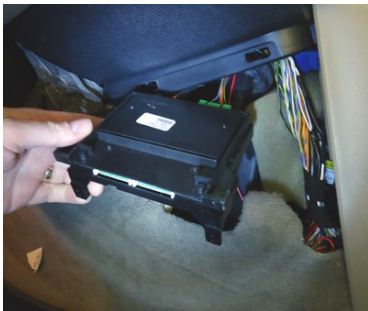
7. Feed the extended fibre optic and green data connectors through the hole under the radio and down to the passenger footwell where the control module will be relocated to.

8. The module can be easily accessed Using the original button panel the time settings on the display can be updated
