29-694

Saab steering wheel control interface

Supported functions

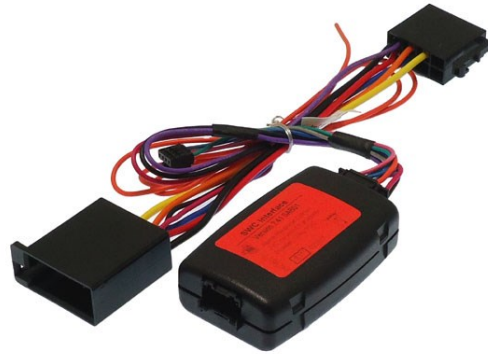
Connection instructions

Connect the head unit specific patch lead to the interface first. If using a universal patch lead, check it is setup correctly. Refer to the diagrams overleaf to check the patch lead is correct.

Identify the steering wheel control signal wire under the steering column. This will be a wire that rests at 4.5V on a 2 or 3 way connector. This voltage will fluctuate when buttons are pressed on the steering wheel.

Connect the loose orange wire from the interface to this steering control wire under the steering column.

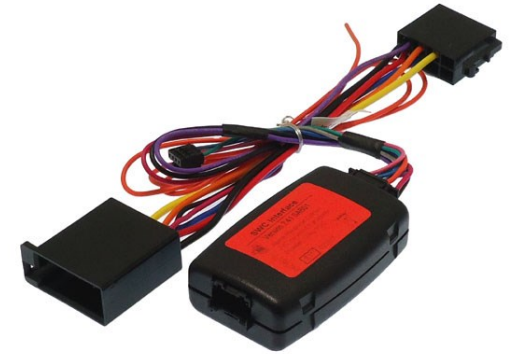
Saab steering wheel control interface

Connection instructions

Identify the steering wheel control signal wire under the steering column. This will be a wire that rests at 4.5V on a 2 or 3 way connector. This voltage will fluctuate when buttons are pressed on the steering wheel.

Connect the loose orange wire from the interface to this steering control wire under the steering column.
