Pacific Accessory Corporation

# - Displaying video on far rear screen of the Cadillac Escalade ESV -

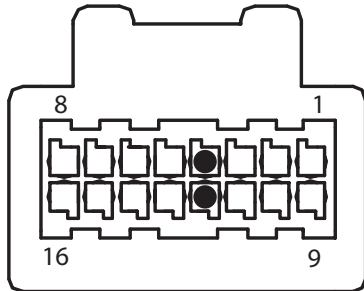
**Solution:** Below is a picture of the connector in which two wires need to be connected for video to be displayed on the far-rear screen. For reference the Connector pictured below is purple or black in color, is located behind the radio, and has the rear speaker leads in it as well. This is **NOT** the GMRVD connector.

2nd Screen Connector Wires

- Pin 4 - DVD Video Signal 2 (+) (Light Green)
- Pin 12 - DVD Video Signal 2 (-) (White)

You will connect these wires to the corresponding positive and negative video wires from the GMRVD connector.

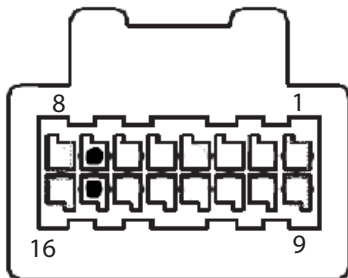
GMRVD Connector Factory Wiring Colors

- Pin 7 - DVD Video Signal 1 (+) (Dark Green)
- Pin 15 - DVD Video Signal 1 (-) (Light Green/Black)
