29-670

Chevrolet steering wheel control interface

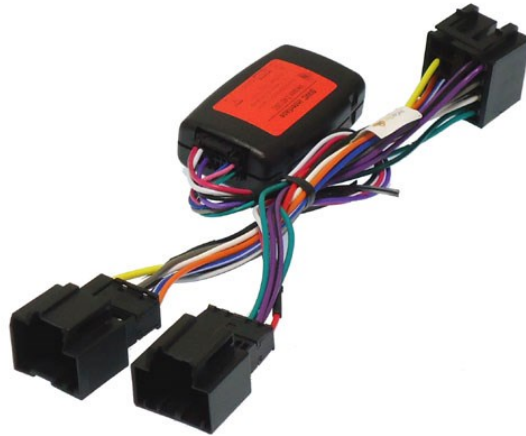
Volume up
Volume down
Seek/track up
Source
On/off

Connect the head unit specific patch lead to the interface first. If using a universal patch lead, check it is setup correctly. Refer to the diagrams overleaf to check the patch lead is correct.

Connect the ISO connectors and patch lead to the new head unit.

Connect the 29-670 harness to the vehicle harness.

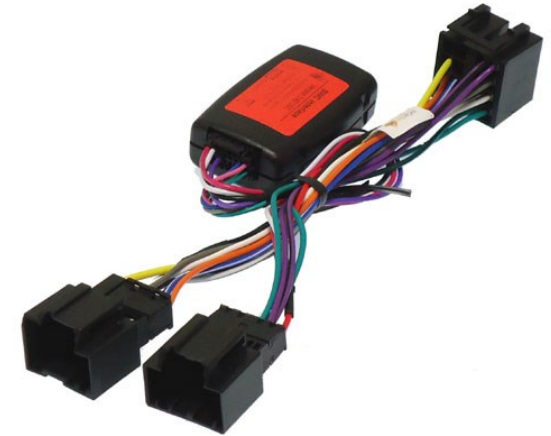
Volume up
Volume down
Seek/track up
Source
On/off

Connect the head unit specific patch lead to the interface first. If using a universal patch lead, check it is setup correctly. Refer to the diagrams overleaf to check the patch lead is correct.

Connect the ISO connectors and patch lead to the new head unit.

Connect the 29-670 harness to the vehicle harness.

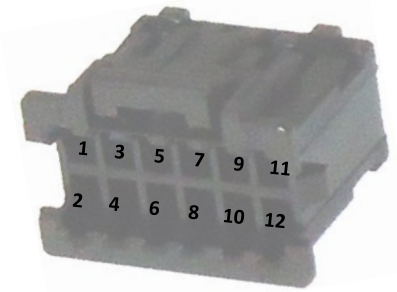
29-000 Self learning units
Single wires pins 1 and 2
No loops
